Solicitation Number
DACA21-03-R-0026
Upgrade Saber Hall
FY-03, Line Item 52067
Volume IV of IV – Environmental Site Assessment Data
May 2003

SUPPLEMENTAL ASBESTOS **SURVEY REPORT**

**BUILDING NO. 8661, SABRE HALL
HUNTER ARMY AIR FIELD, GEORGIA**

**SUPPLEMENTAL ASBESTOS INSPECTION REPORT
HUNTER ARMY AIR FIELD, GEORGIA
BUILDING NUMBER 8661, SABRE HALL**

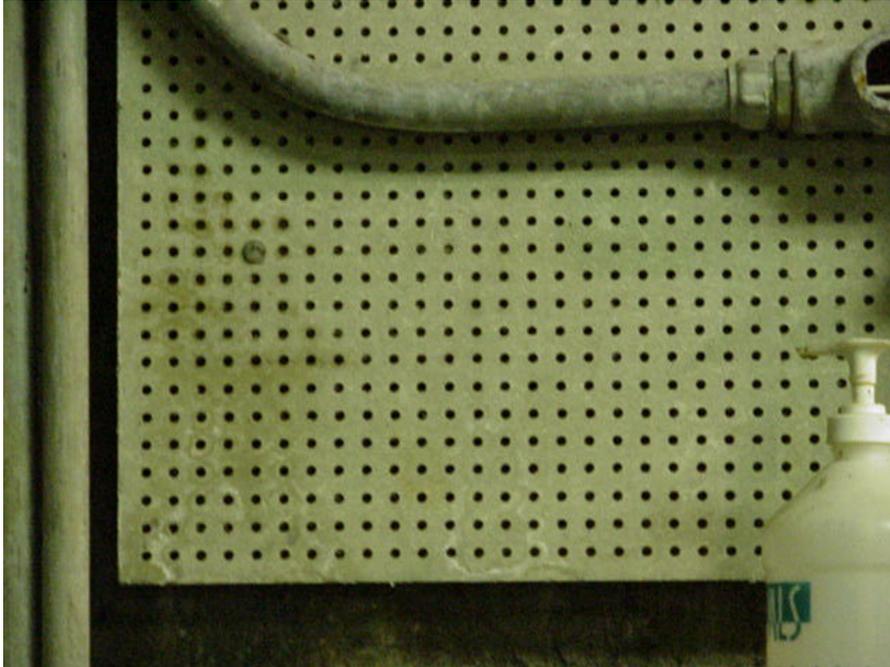
Figure 1. Perforated ACM Board

2' X 2' perforated asbestos cement board used as wall covering on three walls of the mechanical room on the lower level contains asbestos. The material is attached to wood furring strips with nails or screws.

2' X 2' perforated asbestos cement board used as wall covering in the lower level mechanical room contains asbestos.

Figure 1. 2' X 2' perforated ACM board on mechanical room walls

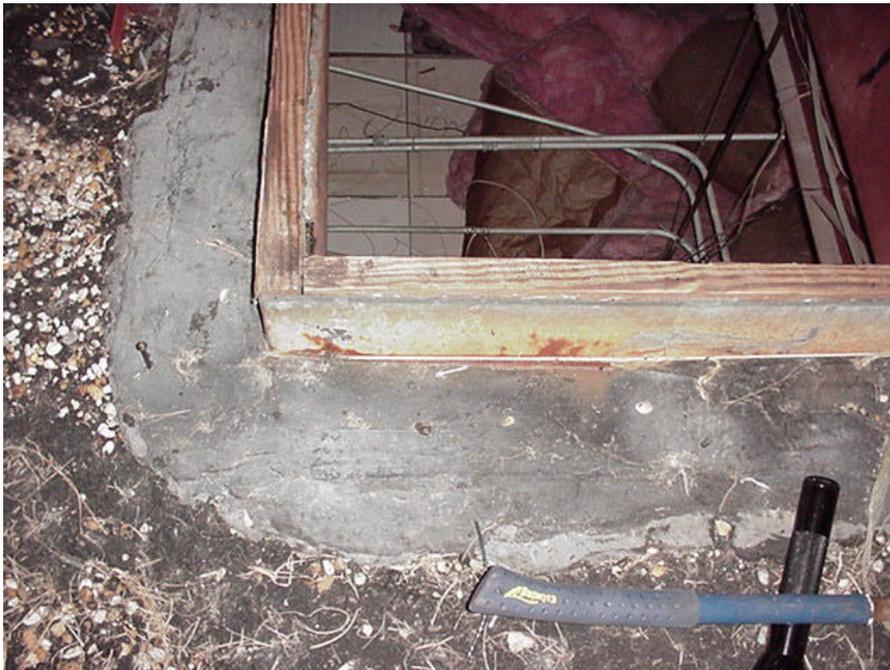
Figure 2. Roofing Cement

Troweled on roofing cement used as patching and flashing material around metal roof vents and roof access scuttle was found to contain positive amounts of asbestos. Flashing felt around these locations was also found to be asbestos containing.

Troweled on roofing cement used for flashing and patching on the original built up roof contains positive amounts of asbestos.

Figure 2. Troweled on roofing cement around roof access door at old flat roof contains asbestos.
