Unit 7 Problems over the years (Taken from various folders) 25 Feb 2003

## History of problems with unit 7, taken from logbooks

2.0 PROJECT SUMMARY  
Unit No. 7 Turbine Generator

The following report is the results of the vibration analysis performed on the Unit No. 7 Turbine Generator located at Richard B. Russell Pump Storage in Elberton, Ga.

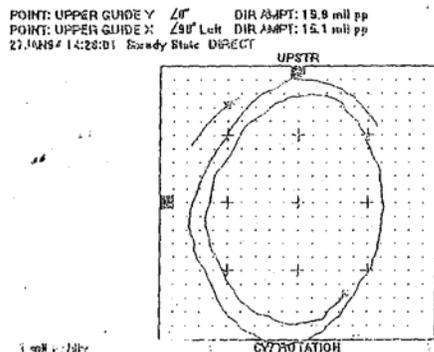
Figure 1: Plot 1

Figure 1 is an orbit for one revolution of the shaft (Plot 1-Appendix A for eight revolutions). This plot exhibits a primary frequency at 3.5-3.65 hz. This frequency component is not related to any common rotor related machinery malfunction, as will be discussed later.

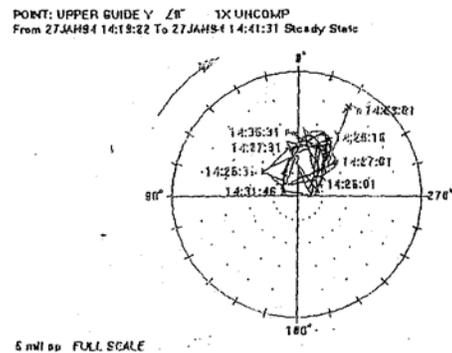
Figure 2: Plot 7

Figure 2 shows represents the 1X APHT for the Upper Guide Y transducer. This is typical for the other transducer locations as shown in Appendix A. The APHT plots are typical for a rub malfunction. The rub may be initiated during the transient high vibration that occurs during the change from condensing operation to pumping operation. Once the rub is initiated, then it continues throughout the pumping mode. This may be further aggravated by the axial position of the rotor. Data supplied by plant personnel after MDS left the site indicates significant axial change from a cold starting/operating condition to a hot (heat soaked) operating condition. This may account for the low vibration levels observed on Unit No. 8 Turbine Generator since it was heat soaked in a generating mode prior to operating in a pump mode. It is also well documented in many case histories that rubs modify machinery resonances. This may account for the unusual frequency observed in Figure 1. Also, more than one malfunction may be present, but the rub malfunction must be resolved.

**Recommendation:** Visually and mechanically inspect seal areas, wear rings, and other parts for evidence of rotor to any stationary part rubbing.
