Unit 7 Problems over the years (Taken from various folders) 25 Feb 2003

## History of problems with unit 7, taken from logbooks

2.0 PROJECT SUMMARY  
Unit No. 7 Turbine Generator

The following report is the results of the vibration analysis performed on the Unit No. 7 Turbine Generator located at Richard B. Russell Pump Storage in Elberton, Ga.

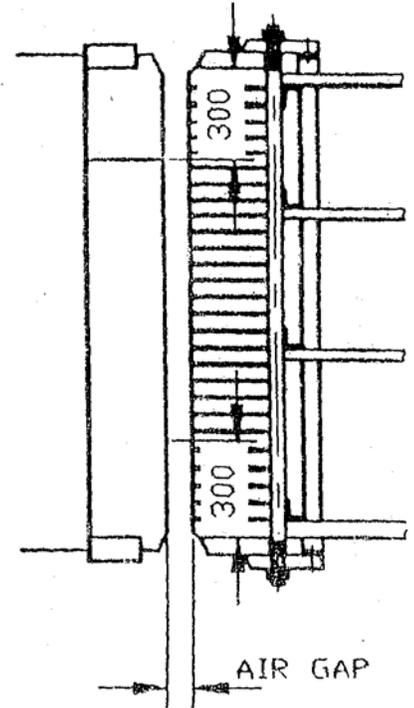
POLE NO: 1 UPSTREAM

POLE	AIR GAP	
	TOP	BOTTOM
1	.576	.586
2	.575	.576
3	.586	.564
4	.573	.550
5	.588	.550
6	.579	.547
7	.587	.546
8	.578	.544
9	.590	.541
10	.602	.561
11	.585	.545
12	.591	.572
13	.572	.565
14	.581	.557
15	.590	.557
16	.575	.564
17	.569	.562
18	.570	.557
19	.564	.569
20	.567	.556
21	.565	.557
22	.570	.570
23	.569	.565
24	.553	.565
25	.556	.566
26	.568	.575
27	.576	.568
28	.573	.563
29	.574	.573
30	.595	.576
31	.580	.571
32	.584	.580
33	.593	.593
34	.599	.570
35	.599	.575
36	.588	.580
37	.595	.582
38	.591	.567
39	.588	.566
40	.593	.565
41	.586	.573
42	.584	.569
43	.586	.572
44	.586	.574
45	.572	.586
46	.595	.581
47	.594	.570
48	.593	.570

POLE	AIR GAP	
	TOP	BOTTOM
49	.592	.592
50	.598	.573
51	.591	.572
52	.592	.594
53	.589	.577
54	.592	.578
55	.594	.574
56	.591	.574
57	.584	.578
58	.580	.579
59	.579	.578
60	.593	.580

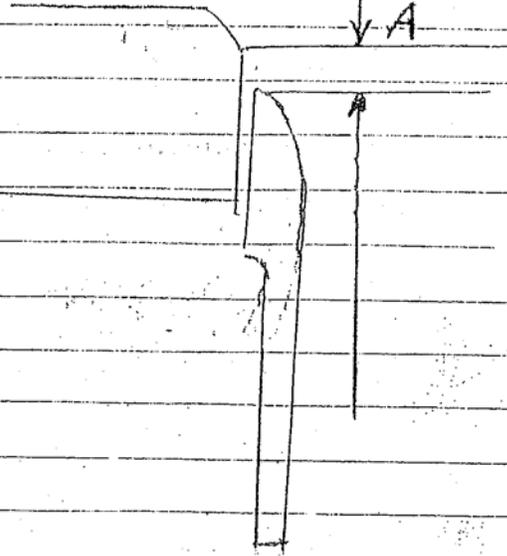
"A" HEIGHT

0°	.172
90°	.180
180°	.184 .187
270°	.200

"B" CLEARANCE

0	.121
90	.133
180°	.132
270°	.129
