# **ASBESTOS SURVEY REPORT**

**BUILDING NO. 8672, LATRINE  
HUNTER ARMY AIR FIELD, GEORGIA**

**ASBESTOS INSPECTION REPORT  
HUNTER ARMY AIR FIELD, GEORGIA  
BUILDING NUMBER 8672, LATRINE**

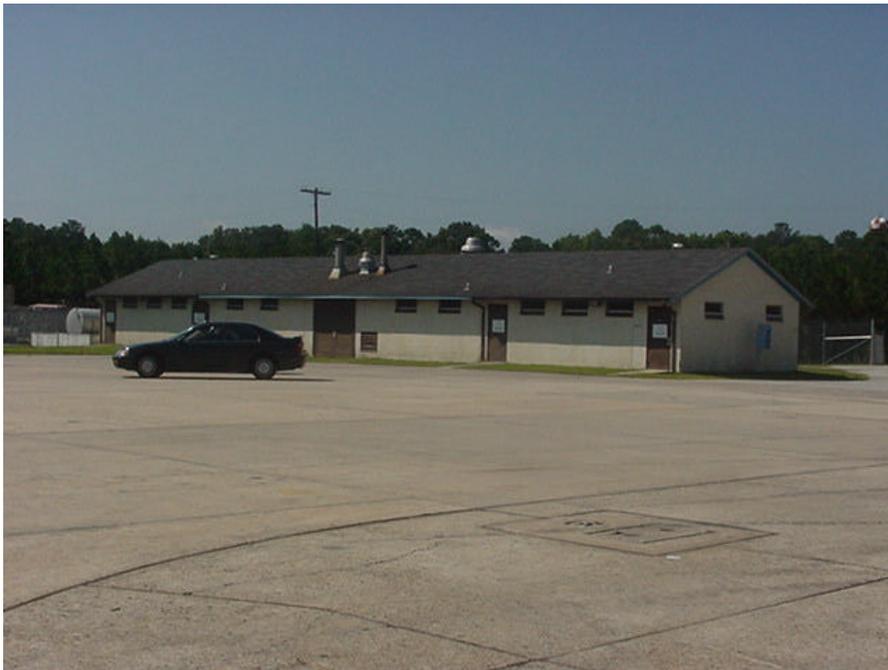
2. Building No. 8672 was built in the 1940s time frame and is a single story structure of concrete masonry block construction with a bare concrete floor slab. The roof is wood frame with a single layer of asphalt shingles.

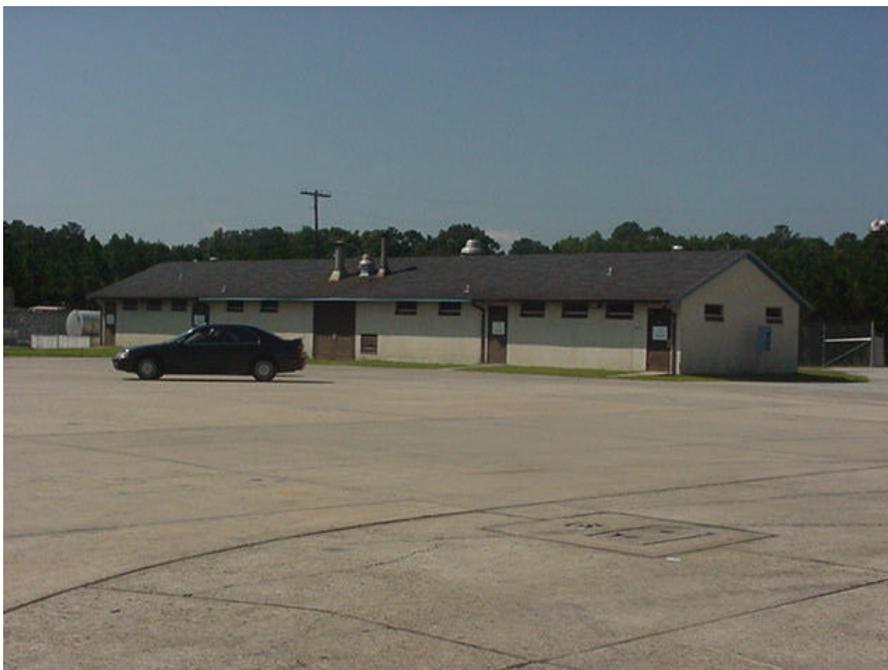
**BUILDING NO. 8672, LATRINE**  
**HUNTER ARMY AIR FIELD, GEORGIA**

3. Building No 8672 was built in the 1940s time frame and is of concrete masonry block construction. The roof system is wooden framing with wood decking covered by asphalt shingles. The floor system is a bare concrete slab. Due to the construction of the building, the TCLP sampling was performed in accordance with composite sample estimated percentages for Stucco/Wood/Block structures in the USAEHA guidance. No physical sampling of other hazardous components was performed, only a visual counting was performed.

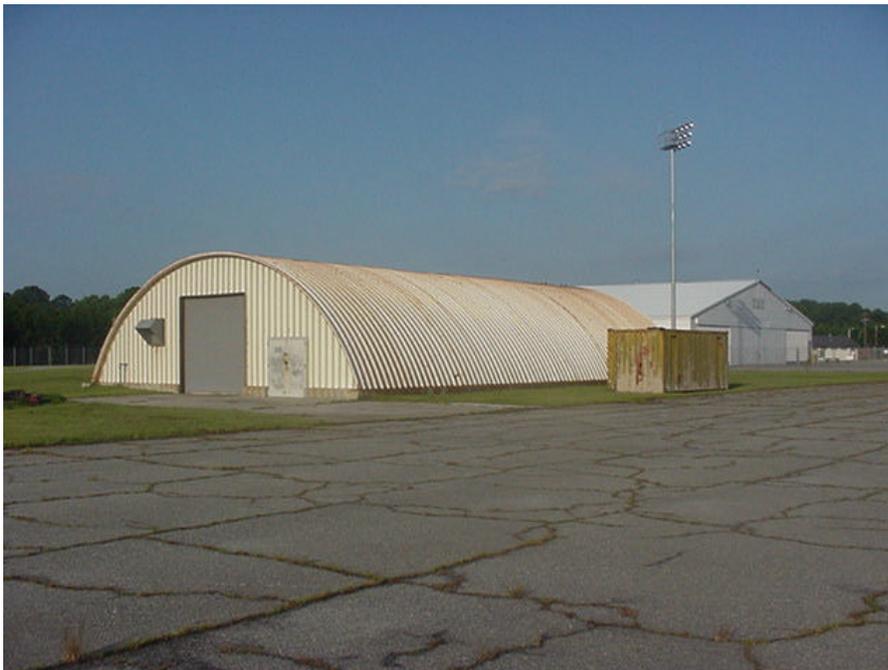
**BUILDING NO. 8675, QUONSET HUT  
HUNTER ARMY AIR FIELD, GEORGIA**

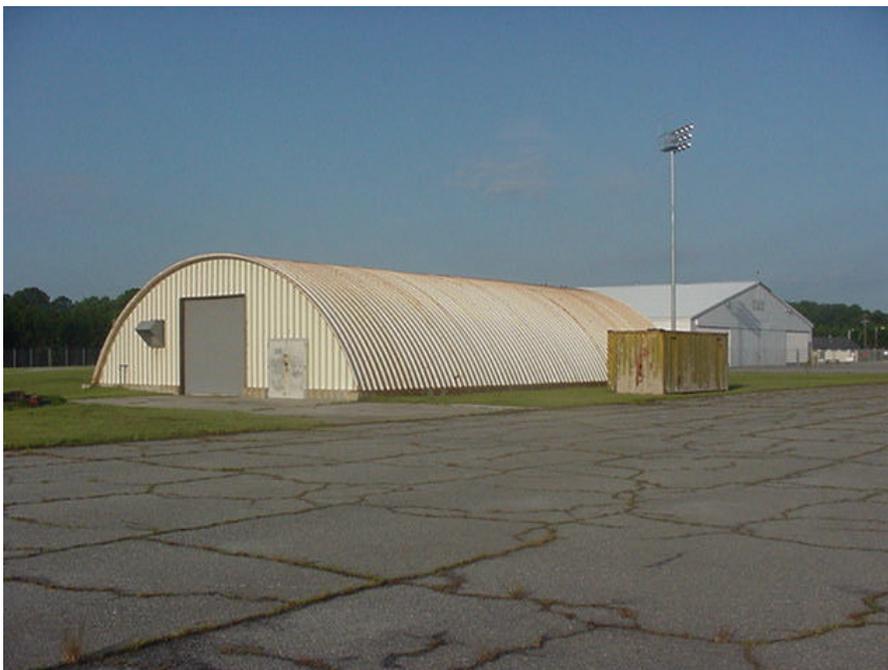
**BUILDING NO. 8675, QUONSET HUT  
HUNTER ARMY AIR FIELD, GEORGIA**

3. Building 8675 was built in an unknown time frame and is of typical all steel Quonset hut construction with a bare concrete floor slab. Due to the construction of the building, the TCLP sampling was performed in general accordance with composite sample estimated percentages for Metal structures in the USAEHA guidance. Since the building is only steel and concrete construction the components for TCLP analysis were adjusted to reflect building construction. These adjustments are indicated in Table 2. No physical sampling of other hazardous components was performed, only a visual counting was performed.

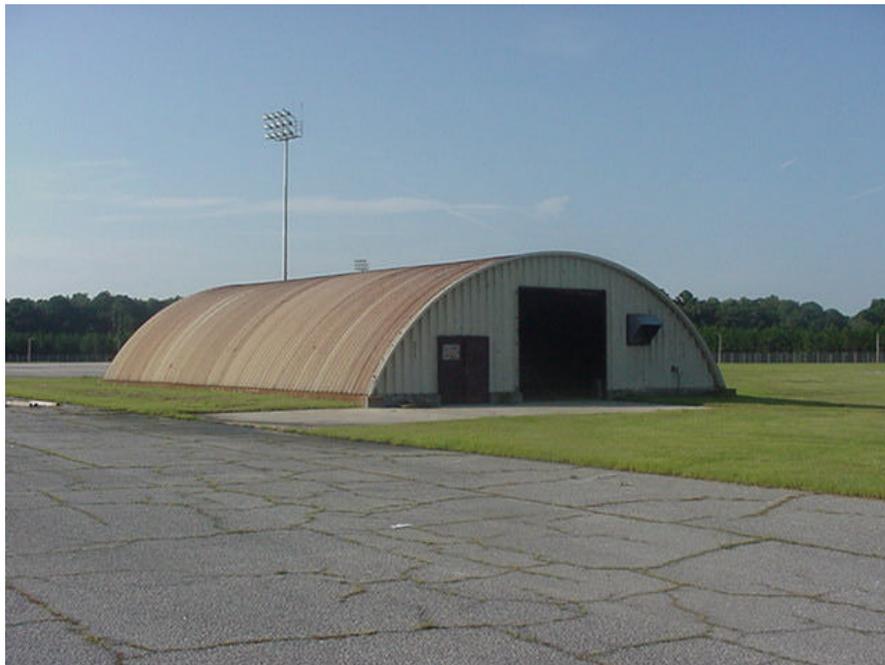
**BUILDING NO. 8676, QUONSET HUT  
HUNTER ARMY AIR FIELD, GEORGIA**

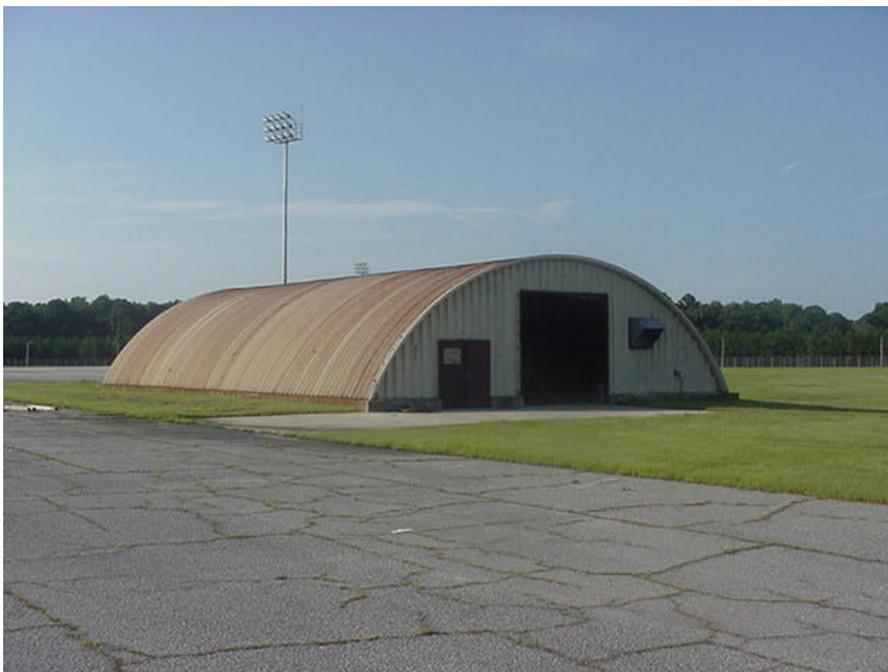
**BUILDING NO. 8676, QUONSET HUT  
HUNTER ARMY AIR FIELD, GEORGIA**
