Barracks Complex

Volume III of III – Hazardous Building Materials Surveys

Hazardous Building Materials Survey

Building No. 6502, Ft. Stewart, Georgia

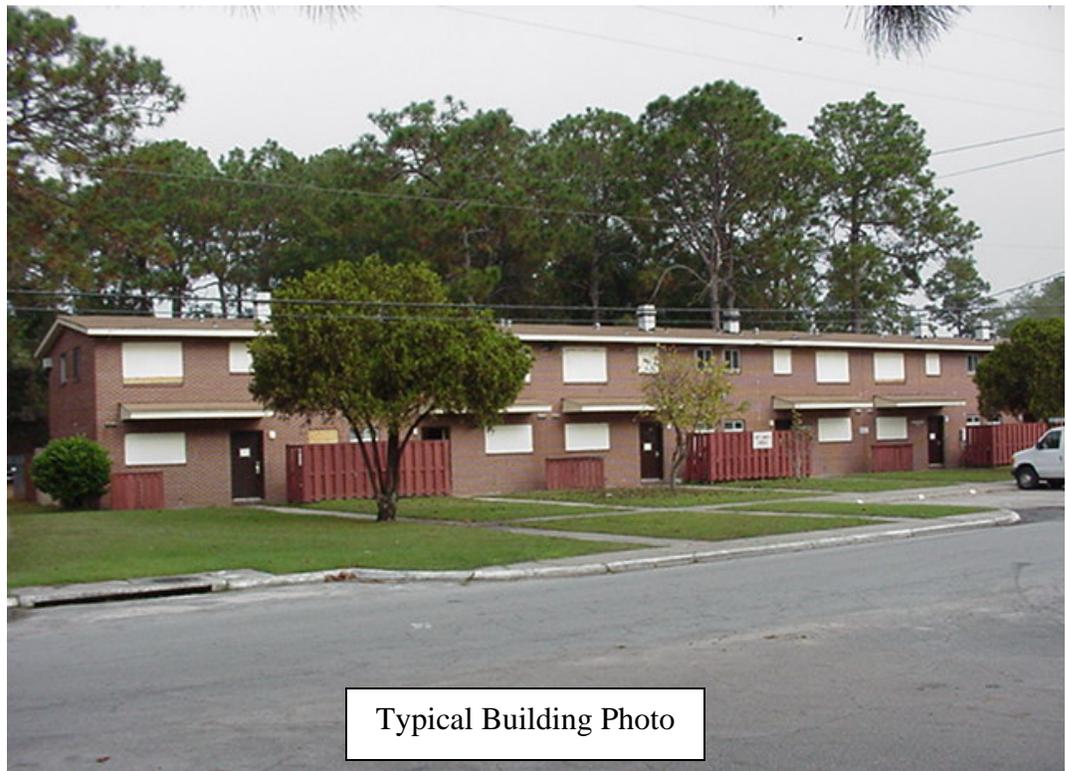
Typical Building Photo

Building No. 6502 is a two-story wood frame structure with brick exterior of 1950s vintage. It is divided into eight identical three-bedroom apartment units. The first floor of each apartment unit consists of a kitchen with pantry/water heater closet, living room, half bathroom (added later), entry hall, storage closet and mechanical closet. The second floor of each unit consists of three bedrooms with closets, a full bathroom, a hallway and a linen closet. Original interior walls and ceilings are constructed of wood framing covered with gypsum board that is in turn covered by approximately $\frac{3}{4}$ inch of hard plaster. Walls separating individual apartment units are constructed of masonry covered with plaster. A half bathroom has been added on the first floor of each apartment unit at some later time the new walls of which are wood frame covered by gypsum board. The first floor is poured concrete slab on grade topped with a combination of wood parquet, sheet vinyl flooring and floor tile. Floors on the second floor are finished hardwood planking over wood sub-flooring in the hallway and bedrooms and ceramic tile in the bathroom. There is no attic space above the second floor; ceilings are attached to the roof joists. Attached wooden storage sheds on the rear of the building are each shared by two apartment units. The storage shed's roofs are constructed of rolled roofing over plywood. All remaining roof structures are asphalt shingles over felt over wood decking. Second story exterior soffits are covered with vinyl siding material over older plywood. Windows have aluminum frames.
